Manhole Inspection Summary

Manhole # **S13GG1001MH**

Insp Date: **6/13/07 2:19 PM**

Location Address: **2656 PIMLICO RD** Cross Street: **LOYOLA SOUTHWAY**

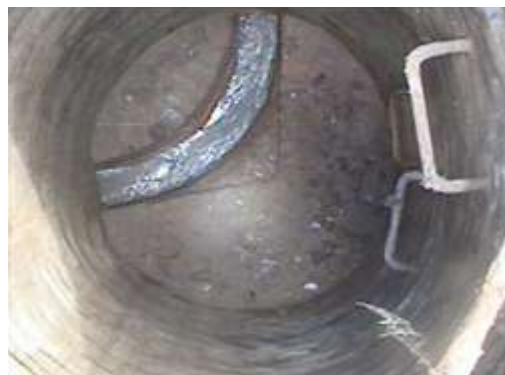
Top View

DEBRIS ON BENCH

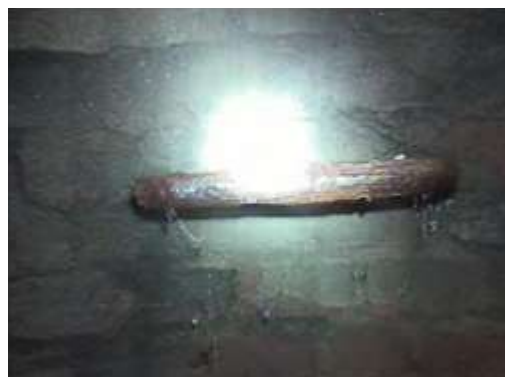
Defect 1

Steps Count: **4** Missing: **0** ☒ **Corroded**

CORRODED RUNG

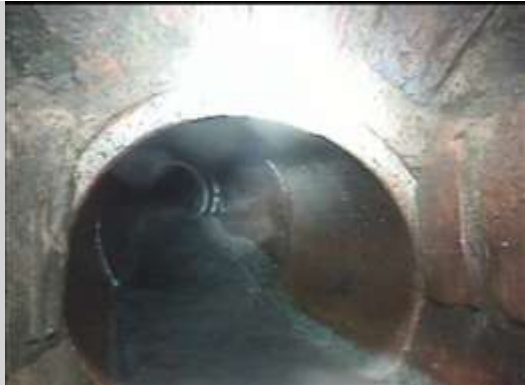
12 O'Clock Outflow

8 in. Circular Gravity Sewer
Pipe Out @ 12 O'Clock

Pipe Height: (in.) Direct
Pipe Material: **Clay** ☐ Pipe Lined
Invert Depth: **9.95** (ft.) Flow Characteristics: **Fast**
Deposits: ☒ None ☐ Mud ☐ Sludge ☐ Debris ☐ Grease
Silt Depth: (in.) Deposits Extent:
Infiltration: **None** Pipe Seal Cond: **Sound**

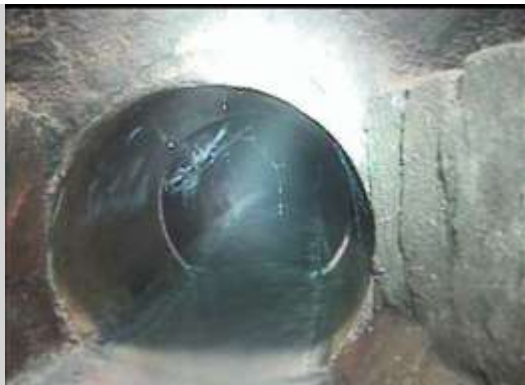
9 O'Clock Inflow

10 in. Circular Gravity Sewer
Pipe In @ 9 O'Clock

Pipe Height: (in.) Direct
Pipe Material: **Clay** ☐ Pipe Lined
Invert Depth: **9.89** (ft.) Flow Characteristics: **Fast**
Deposits: ☒ None ☐ Mud ☐ Sludge ☐ Debris ☐ Grease
Silt Depth: (in.) Deposits Extent:
Infiltration: **None** Pipe Seal Cond: **Sound**
